MICHIGAN DEPARTMENT OF ENVIRONMENTAL QUALITY
WATER BUREAU
JULY 2008

STAFF REPORT

BIOLOGICAL AND WATER CHEMISTRY SURVEYS OF SELECTED STATIONS IN THE
LOOKING GLASS RIVER WATERSHED
SHIAWASSEE AND CLINTON COUNTIES, MICHIGAN
JULY AND AUGUST 2007

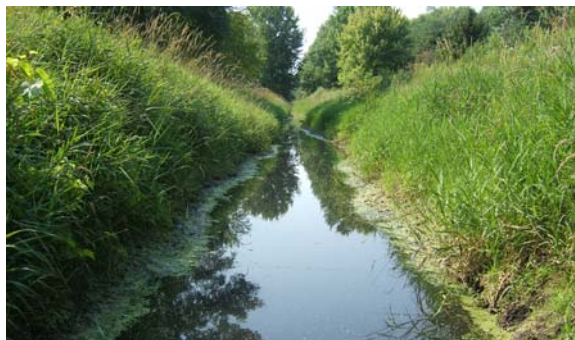
Figure A: Clise Drain upstream of Cutler Road.

Clise Drain was sampled at Cutler Road (Station 3). The glide/pool habitat was rated at the low end of marginal (60; moderately impaired; Table 2a). This stream is a maintained agricultural drain with a straight channel, lack of woody debris, and

a riparian zone consisting of primarily grasses (Figure A). The stream was approximately 3 inches deep with little stream velocity. Pool variability was absent and the substrate consisted of silt that was more than 2 feet deep in places. The macroinvertebrate community scored acceptable (-2; Tables 2b, c). Fish were sampled at this station and scored poor. Only 37 central mudminnows (*Umbra limi*) were found in a 900 foot sample reach that was electrofished for 40 minutes (Table 2d). The low diversity and numbers of fish can most likely be attributed to the lack of habitat in the stream due to drain maintenance activities. Clise Drain was also observed at Clise Road. The drain was barely flowing and was choked with duckweed. The stream channel was very similar to conditions at the Cutler Road crossing.

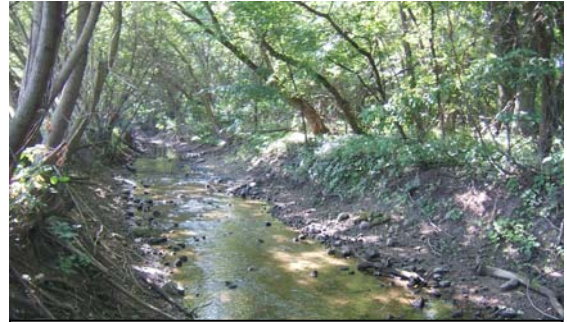
The Looking Glass River was sampled at 4 stations in the upper portion of the watershed (Stations 9, 10, 11, and 12). Station 9 (the most upstream station) was sampled at Godfrey Road. The riffle/run habitat at Station 9 was rated marginal (96; moderately impaired; Table 4a). The Looking Glass has been historically straightened and dredged in this portion of the watershed. Cobble and gravel were present; however, riffles were 50% embedded. Large woody debris was lacking. The river appeared flashy and the stream channel was deeply incised (up to 4 feet) (Figure B). Debris was piled up at the double box culvert, further suggesting flashiness. The macroinvertebrate community scored acceptable (2; Tables 4b, c).

Figure B: Looking Glass River upstream of Godfrey Road.

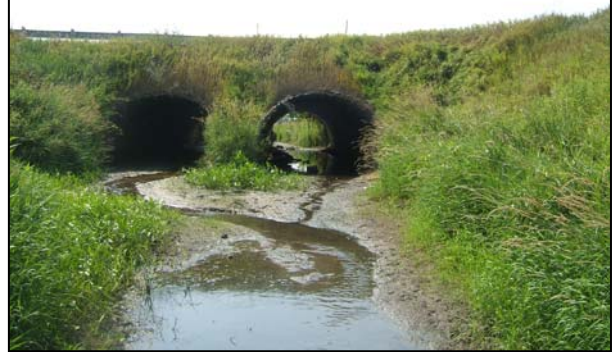
Station 13 was sampled at State Road and was the most upstream station in the Remy-Chandler Drain watershed. The glide/pool habitat at Station 13 was rated as poor (43; severely impaired; Table 5a). The station had very steep banks where the channel has been incised more than 30 feet deep. The riparian area consisted of closely cropped grass. There was very little flow in the stream. The substrate was dominated by sand and silt. Sand deposition was evident in the form of sand bars at the road culvert (Figure C). Epifaunal substrate was absent except for the large amount of aquatic vegetation. Pools were almost absent due to the large amount of sedimentation. The macroinvertebrate community scored at the low end of acceptable (-3; Tables 5b, c).

Figure C: Remy-Chandler Drain upstream of State Road.

Remy-Chandler Drain. In preparation for the 2007 field season, Lansing District NPS staff noted concerns from a local watershed group regarding sedimentation issues in the Remy-Chandler Drain as a result of a large increase in development and construction in this watershed. The drain was observed at several road crossings. There were no specific sources of sedimentation visible from the road crossings; however, the entire watershed is obviously a maintained drain with limited riparian zone vegetation, and deeply incised channels that have a large amount of erosion potential. Macroinvertebrate communities were rated as acceptable at Stations 13, 14, and 15. The habitat was rated as poor at Station 13 and at the low end of marginal at Stations 14 and 15.

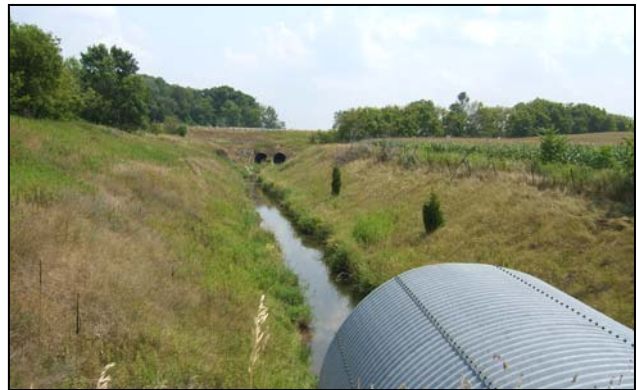
Station 14 was sampled at Wood Road. The glide/pool habitat was rated as marginal (65; moderately impaired; Table 5a). The stream channel is straight at this station and flows through a channel that is incised for than 50 feet deep (Figure D). The riparian area consisted of grass to the top of the steep banks where there are trees on one side of the stream and an agriculture field on the other. The stream flows under I-69 just upstream of this station via 2 culverts. The Wood Road culvert is 20 feet in diameter due to the deep ravine (Figure C). The substrate at Station 14 was dominated by silt and sand. Epifaunal substrate was absent except for the large amount of *Elodea* species and some overhanging grass. Cobble and gravel could be felt but was buried under the sediment. The macroinvertebrate community scored acceptable (0; Tables 5b, c).

Figure D: Remy-Chandler Drain upstream of Wood Road

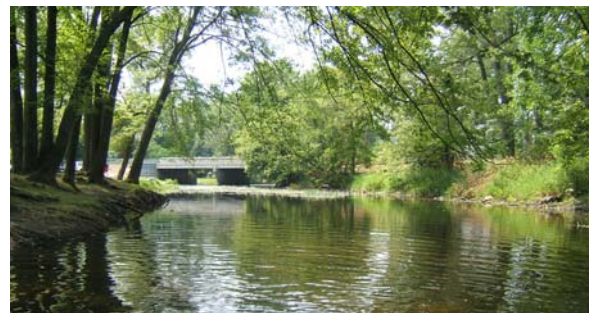
Figure E: Looking Glass River upstream of Dewitt Road, looking downstream.

stations, upstream (Station 17) and downstream (Station 18) of the Southern Clinton County Wastewater Treatment Plant (SCC WWTP). The glide/pool habitat at Station 16 was rated as good (107; slightly impaired; Table 6a). There was a good diversity of epifaunal substrate at this station. Cobble and gravel were available, but were deeply embedded. Aquatic macrophytes and woody debris were also present. Sedimentation was evident in the form of sand bars. The riparian area vegetation has been greatly reduced at this station. The station is in a park that has a maintained yard right to the edge of the stream. There are several large trees along the stream bank within the park. The stream bank is being deeply eroded along the park side and the trees are in danger of falling into the river (Figure E). The macroinvertebrate community scored acceptable (2; Tables 6b, c).

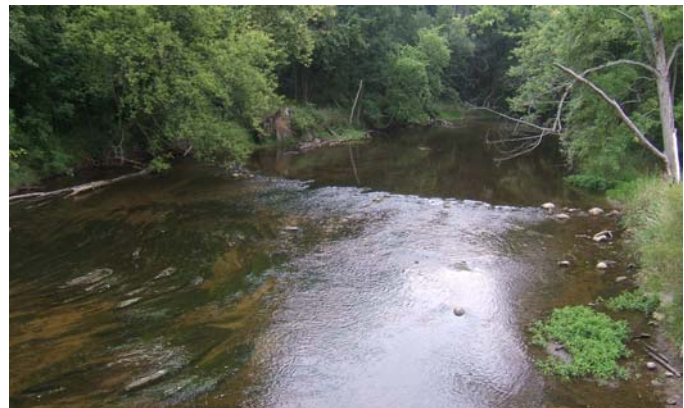
Station 23 was the most downstream Looking Glass River station and was sampled at Monroe Road, approximately 3 miles east of Portland. The riffle/run habitat (Figure F) was rated as good (146; slightly impaired; Table 7a), and had the highest habitat score for any station sampled in the watershed in 2007. The station had a large amount and diversity of epifaunal substrate in the form of cobble and gravel. The natural flow of the reach was somewhat altered by an area where rocks were built up across the width of the stream and restricted flow through a 6 foot section of the river. This restriction caused an increase in stream velocity. Siltation was minimal in this reach due to the higher water velocity. There was also good habitat variety and pool diversity at this station. Erosion potential was high at this station because in one area the riparian zone consisted of a house located on a high bluff with only large trees left as vegetative protection. The macroinvertebrate community at this station scored excellent (7; Tables 7b, c). This station was the only one sampled in the Looking Glass River in 2007 that scored an excellent macroinvertebrate rating.

Figure F: Looking Glass River upstream of Monroe Road.

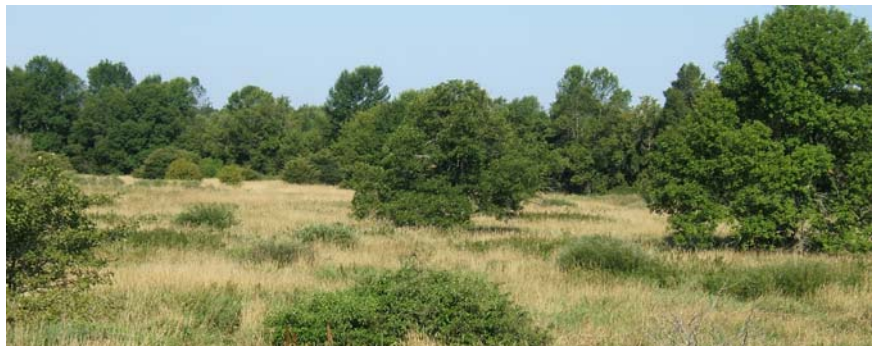
- 3) **Laingsburg WWSL** (MIG580227) discharges treated sanitary wastewater seasonally from outfall 001 to a wetland near the Looking Glass River (Station SV-2, Figure 1a). The facility is required to report the monthly average total phosphorus discharge concentration. The facility's current permit states that the facility directly discharges to the Looking Glass

Figure G: Wetland at Laingsburg WWTP

River; however, a site visit confirmed that the outfall discharges to a wetland area and then to a county drain before discharging to the Looking Glass River. The next NPDES permit for this facility will note this change and identify the wetland as the receiving water, if the present discharge location is retained.
